NTSB-AAR-70-12

AIRCRAFT ACCIDENT REPORT

MOHAWK AIRLINES, INC.
FAIRCHILD HILLER FH-227B, N7811M
NEAR GLENS FALLS, NEW YORK
NOVEMBER 19, 1969

Adopted: June 25, 1970

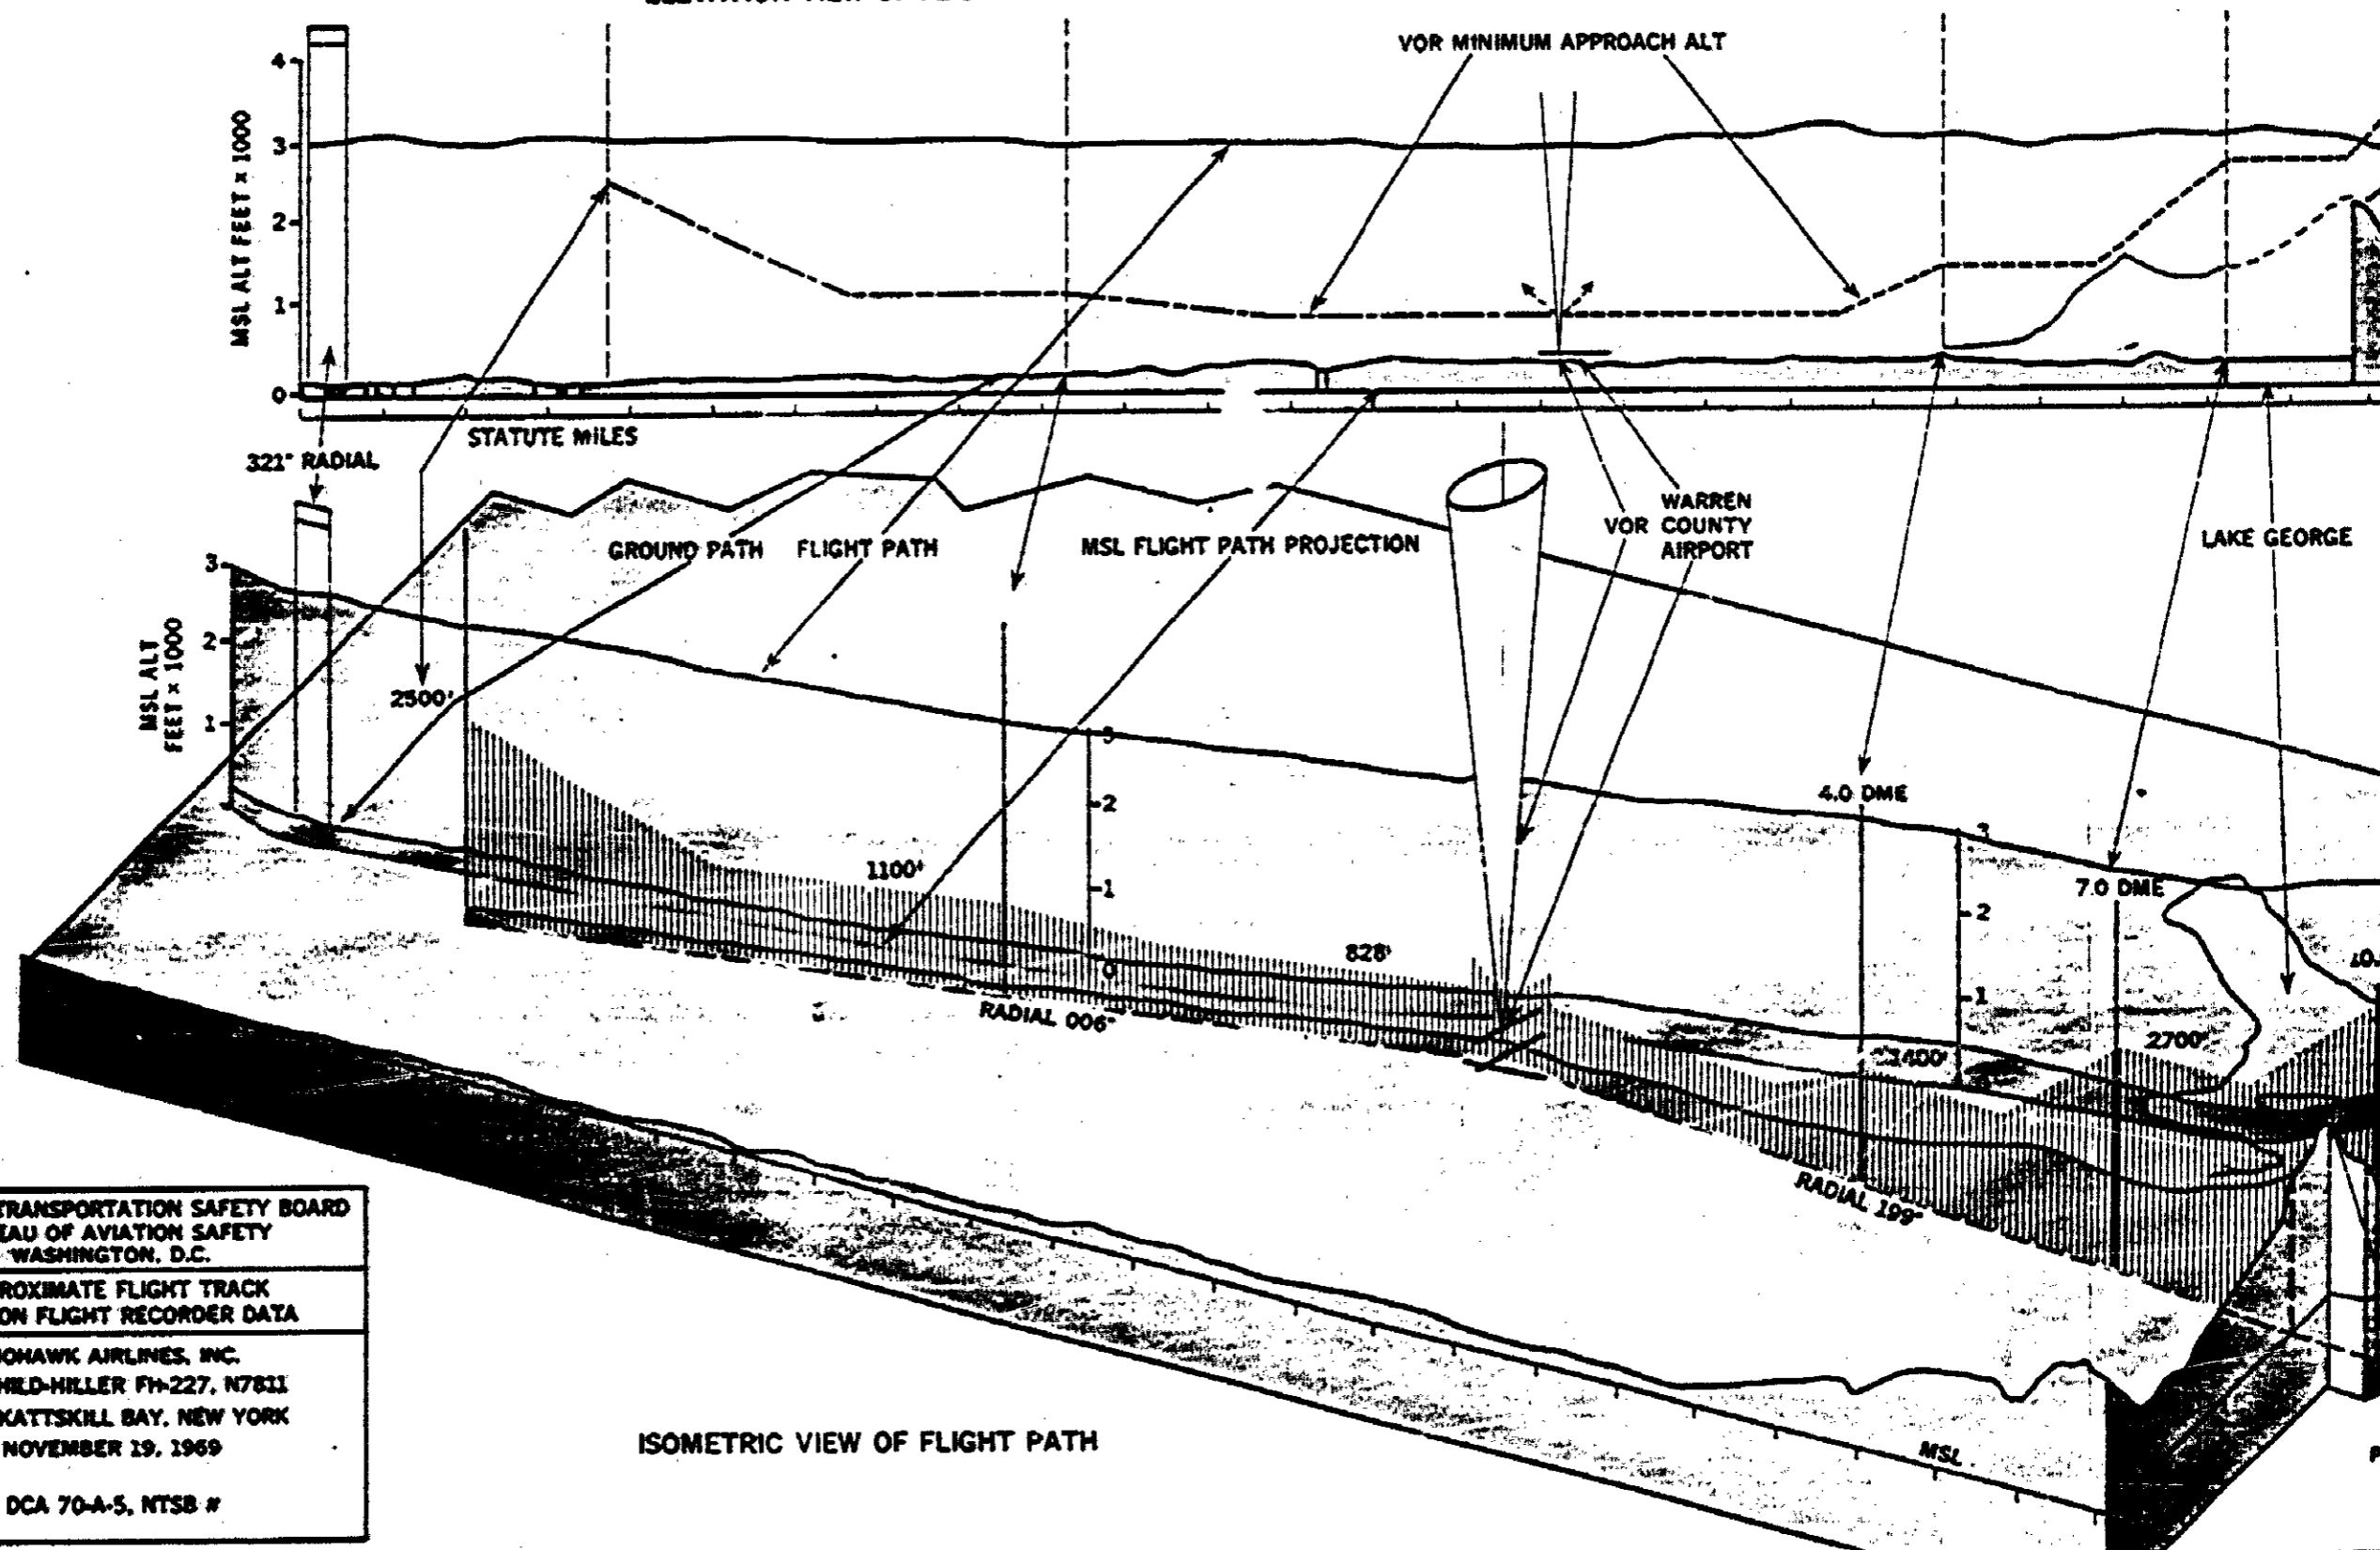
ELEVATION VIEW OF FLIGHT PATH

According to the flight recorder data available, however, Mohawk 411 held its 3,000-foot altitude and its northerly course for some seven nautical miles north of the airport. The aircraft then made a looping right-hand turn, and had nearly reached a return heading for the airport when it began a descent. The Board held that this descent "was intentional." One minute and eight seconds later the aircraft struck trees and was thrown against the near-vertical face of Pilot Knob Mountain. At impact, the aircraft was descending at a 12-degree angle in a 12-degree right bank.

Whether the descent was initiated to clear clouds in the area or because the 10 NM DME was reached could not be determined. Suffice it to say that descent initiation at 1 minute and 8 seconds prior to impact was intentional by the crew. The momentary level-off at 28 seconds prior to impact could have been a result of the turn reversal from 168° to 186° or it could have been a belated, intentional level-off that should have occurred at 2,700 feet. Regardless of the cause for the 6-second level-off, the indicated airspeed began to drop immediately thereafter and to fluctuate. In the period 12 seconds before impact, the airspeed decreased from 110 knots to 84 knots.
